# Important Product Information

## PACSystems\* RX3i

IC695CPU315-CN

### PACSystems\* RX3i CPU

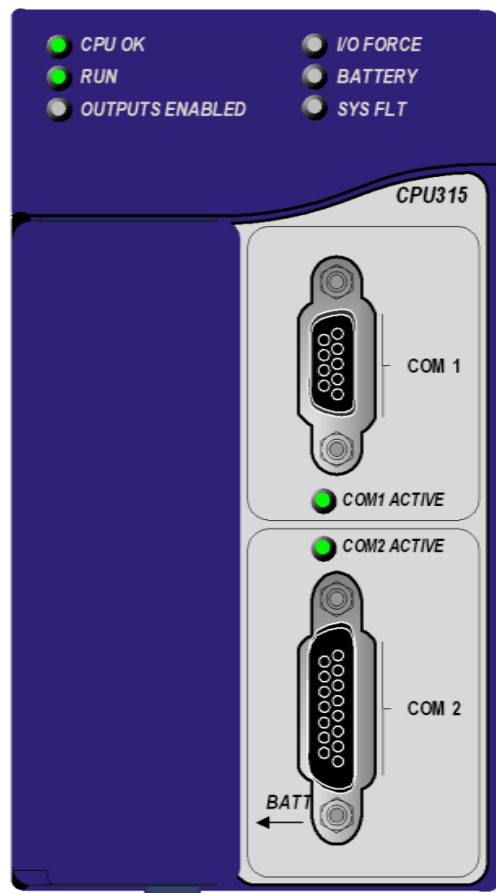
The PACSystems\* RX3i CPU can be used to perform real time control of machines, processes, and material handling systems. The CPU communicates with the programmer and HMI devices via a serial port using SNP Slave protocol. It communicates with I/O and smart option modules over a dual backplane bus that provides:
