PACSystems* RX3i

IC695ETM001-HV

Ethernet Interface Module

GFK-2332W

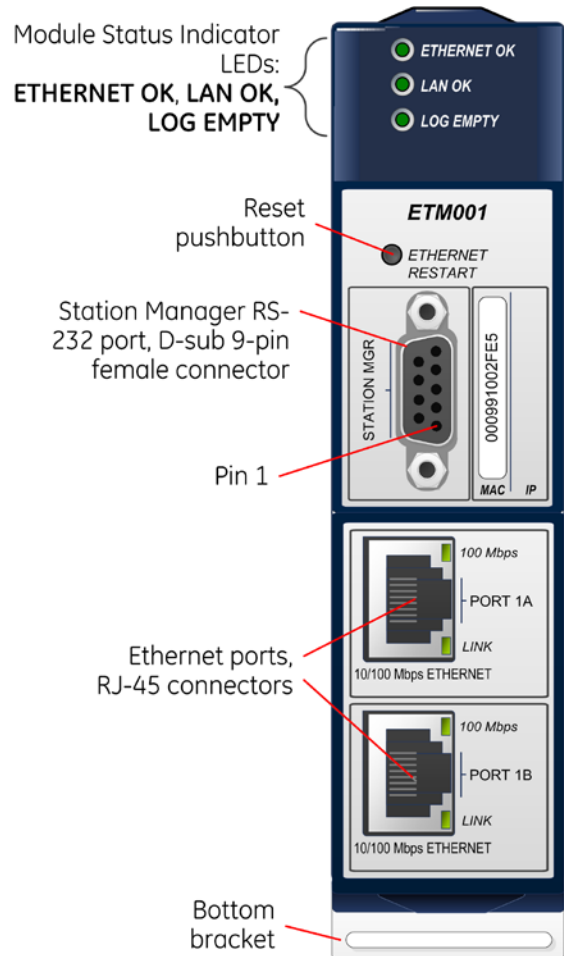
- Two auto-sensing 10Base T / 100Base TX RJ-45 shielded twisted-pair Ethernet ports for direct connection to either a 10BaseT or 100BaseTX IEEE 802.3 network without an external transceiver. There is only one interface to the network (only one Ethernet MAC address and only one IP address).

- LEDs: Ethernet OK, LAN OK, Log Empty, individual port activity and speed LEDs.
- Configurable stand-alone Redundant IP addressing, which allows a single IP address to be assigned to corresponding Ethernet modules in two different controllers. The Redundant IP address is configured in addition to the normal unique IP address of each Ethernet module. Under application logic control, only the Ethernet module in the active unit can use the Redundant IP address.
