### Important Product Information

The Ethernet Interface Module, IC695ETM001, connects a PACSystems RX3i controller to an Ethernet network. It enables the RX3i controller to communicate with other PACSystems equipment and with Series 90 and VersaMax controllers. The Ethernet Interface provides Transmission Control Protocol and Internet Protocol (TCP/IP) communications with other control systems, host computers running the Host Communications Toolkit or programmer software, and computers running the TCP/IP version of the programming software. These communications use the Service Request Transport Protocol (SRTP), Modbus TCP, and Ethernet Global Data (EGD) protocols over a four-layer TCP/IP (Internet) stack.

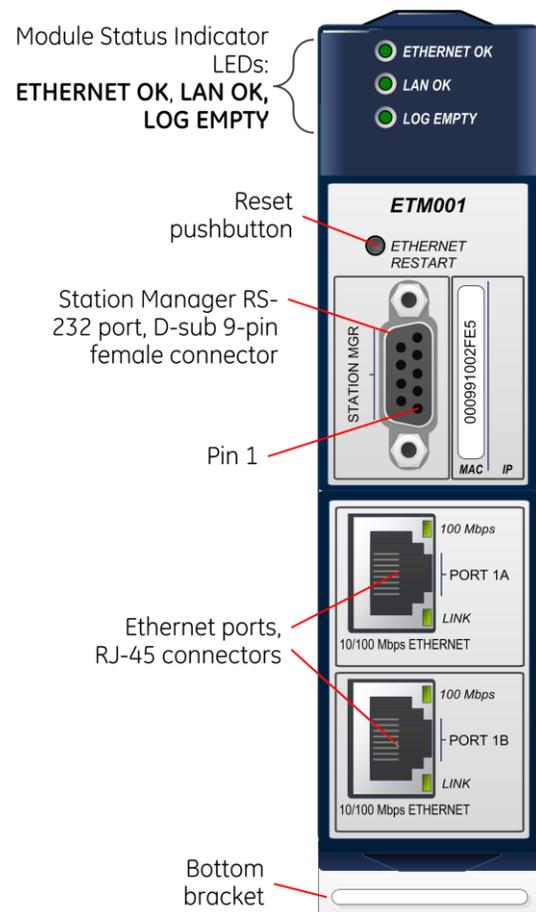
Figure 1: ETM001 Front View

- Two auto-sensing 10Base T / 100Base TX RJ45 shielded twisted-pair Ethernet ports for direct connection to either a 10BaseT or 100BaseTX IEEE 802.3 network without an external transceiver. There is only one interface to the network (only one Ethernet MAC address and only one IP Address).

- LEDs: Ethernet OK, LAN OK, Log Empty, individual port activity and speed LEDs.
- Configurable stand-alone Redundant IP Addressing, which allows a single IP Address to be assigned to corresponding Ethernet modules in two different controllers. The Redundant IP Address is configured in addition to the normal unique IP Address of each Ethernet module. Under application logic control, only the Ethernet module in the active unit can use the Redundant IP Address.

<sup>1</sup> Pin 1 is at the bottom right of the Station Manager port connector as viewed from the front of the module (see [Figure 1](#)).
