PACSystems™ RX3i

ETHERNET INTERFACE MODULE

(IC695ETM001-JZ)

Version 6.50

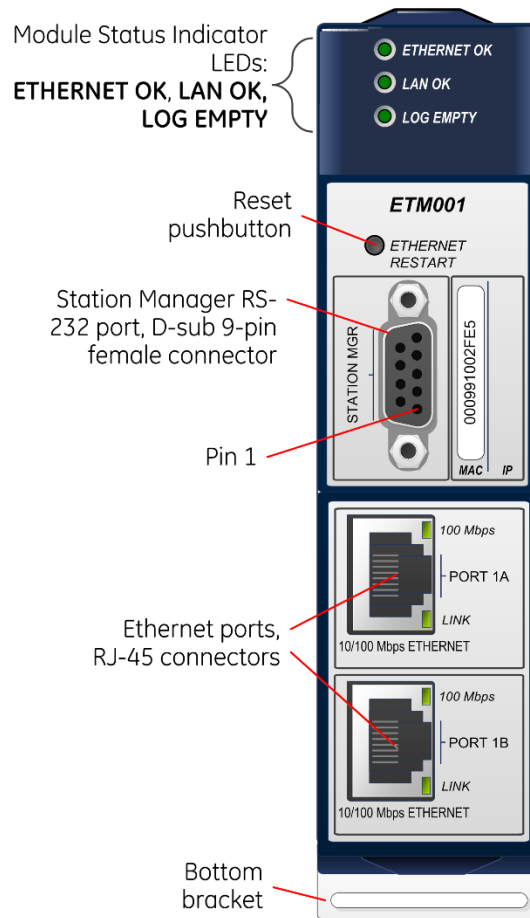
The Ethernet Interface Module, IC695ETM001, connects a PACSystems RX3i controller to an Ethernet network. It enables the RX3i controller to communicate with other PACSystems equipment and with Series 90 and VersaMax controllers. The Ethernet Interface provides Transmission Control Protocol and Internet Protocol (TCP/IP) communications with other control systems, host computers running the Host Communications Toolkit or programmer software, and computers running the TCP/IP version of the programming software. These communications use the Service Request Transport Protocol (SRTP), Modbus TCP, and Ethernet Global Data (EGD) protocols over a four-layer TCP/IP (Internet) stack.

- Two auto-sensing 10Base T/100Base TX RJ45 shielded twisted-pair Ethernet ports for direct connection to either a 10BaseT or 100BaseTX IEEE 802.3 network without an external transceiver. There is only one interface to the network (only one Ethernet MAC address and only one IP Address).

- Internal network switch with Auto negotiate, Sense, Speed, and crossover detection.
- Recessed Ethernet Restart pushbutton permits manually restarting the Ethernet firmware without power cycling the system.
